### Caso clínico

# A malfunctioning nasogastric feeding tube

(Nutr Hosp. 2013;28:229-231)

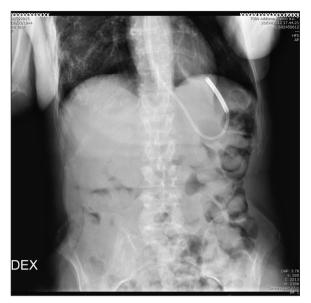
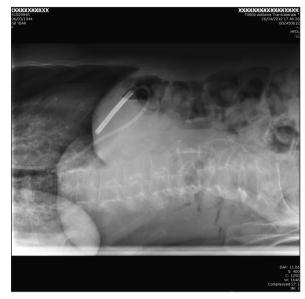
Fig. 1.—Decubitus views of the abdomen demonstrating the presence of a loop in the tube and a tip pointing upwards in the direction of the gastric fundus (Plot A, supine decubitus; Plot B, lateral decubitus).

but without giving any particular warning (fig. 1). After the initiation of enteral nutrition, the patient began to vomit immediately and the physician responsible for the patient was not able to provide an explanation. Only after he had personally reviewed the radiograph he understood that a loop in the tube and its tip pointing upwards did not allow a safe infusion of the feeding formula. Therefore, the feeding tube was repositioned endoscopically, paying attention to the positioning of the tip in the gastric antrum, and the administration of the formula was carried out without further problems. After the resolution of pneumonia. swallowing disturbances were investigated by means of videofluoroscopy and the results of the test indicated the placement of a gastrostomy. The patient is currently on long-term home enteral nutrition.

If we refer to our case it is clear that vomiting was due to an «improper» placement, although we cannot say that every nasogastric tube positioned in such a way can not be used or operates improperly. The tube crossed the diaphragm and deviated to left, a condition that mat be suggestive for a safe use<sup>5</sup>. It could not be recommended that the tip of the feeding tube should be placed in the gastric antrum, although it could be reasonably sustained that it would best operate when the tip is pointing down. The same may apply to decompressive tube drainages. On the other hand, in the present clinical case the report of the radiologist did not arise any suspicion about a malpositioning or even a potential malfunctioning. With this background of consideration, because the responsibility on beginning the feeding seems to be left to the judgment of the radiologist, we believe it could be proposed that:
